US Army Corps
of Engineers®

Huntington District

Today, Zoar Levee & Diversion Dam is a Dam Safety Action Classification I (DSAC I) Project, as progression toward failure may have begun. To remedy the risk the project has, the U.S. Army Corps of Engineers has implemented several measures to reduce the risk and is completing a Dam Safety Modification Study to find the best way to manage the risk long-term.

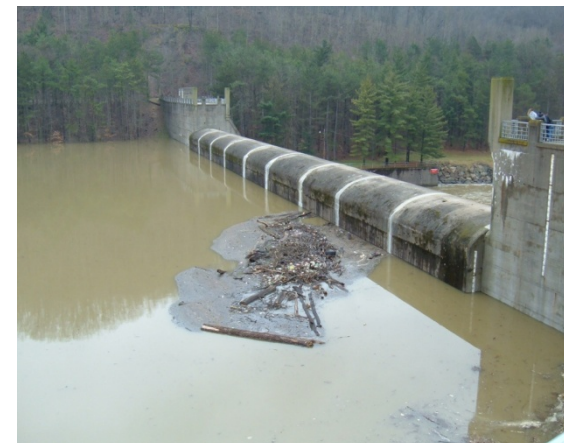
To the right is a picture of water impounded to elevation 907.4 feet in January 2005 behind Dover Dam. This represents the highest water has ever been held behind Dover Dam and is referred to as the “Pool of Record”. The middle part of the dam is called the spillway or the portion of the dam that is designed to be overtopped. The spillway is located at elevation 916 feet.

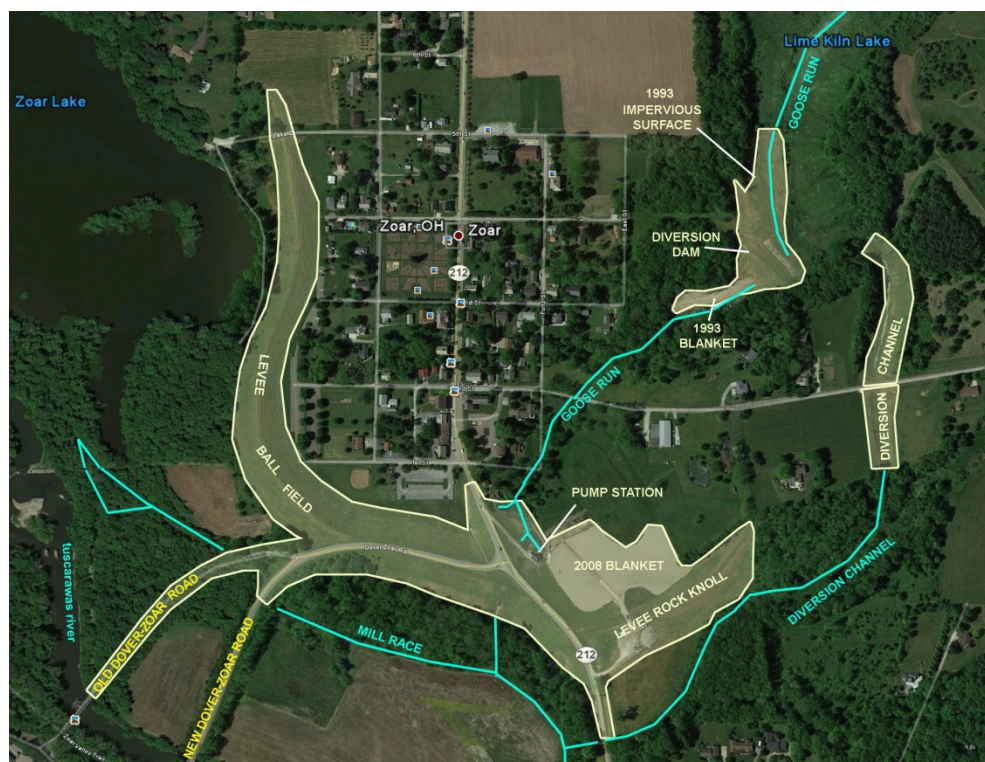
This is an aerial photograph of Zoar Levee & Diversion Dam. The levee is generally divided into two reaches. The “Ball Field” side is located on the west side of Route 212 and is named for the little league baseball field located here. This portion of the levee is founded on approximately 130 feet of sands and gravels that allow water to move under the levee which can cause concern about the long-term stability of the project. The “Rock Knoll” side is located on the east side of Route 212 and is named for a localized bedrock high point that extends upward to near the base of the levee. However, this bedrock has several voids that allow water to seep through it and can also cause stability problems.

The diversion dam is located on Goose Run and was built to help control interior flooding in Zoar Village. The diversion dam is founded on and next to the same type of bedrock as the Rock Knoll.

It once impounded a permanent lake, but now it only impounds water behind it when required to. The diversion channel is for overflow water to keep the diversion dam from being overtopped. Other features of the project include a pump station located where Goose Run meets Zoar Levee. Under normal circumstances, Goose Run flows underneath the levee before joining an old mill race and proceeding to the Tuscarawas River. However, when Zoar Levee is holding back water being retained by Dover Dam, the tunnel that Goose Run flows through must be closed. Once that tunnel is closed, the pump station pumps Goose Run’s water up and over the levee in three pipes. It works much like a sump pump. Evidence of two stone blankets installed by the U.S. Army Corps of Engineers, Huntington District can also be seen. The 1993 blanket is located downstream of the diversion dam and was constructed in 1993 to help control water leaking through bedrock in the dam’s abutment. This is called “abutment seepage”. The same year impervious soil and fabric was also placed on the upstream side of the diversion dam to cover holes where water was leaking. The 2008 blanket is located on the interior side of the Rock Knoll. The 2008 blanket was constructed in March 2008 when large holes, called “boils” opened up. These boils caused concern that the levee could have lost some structural stability due to potential erosion of foundation materials.

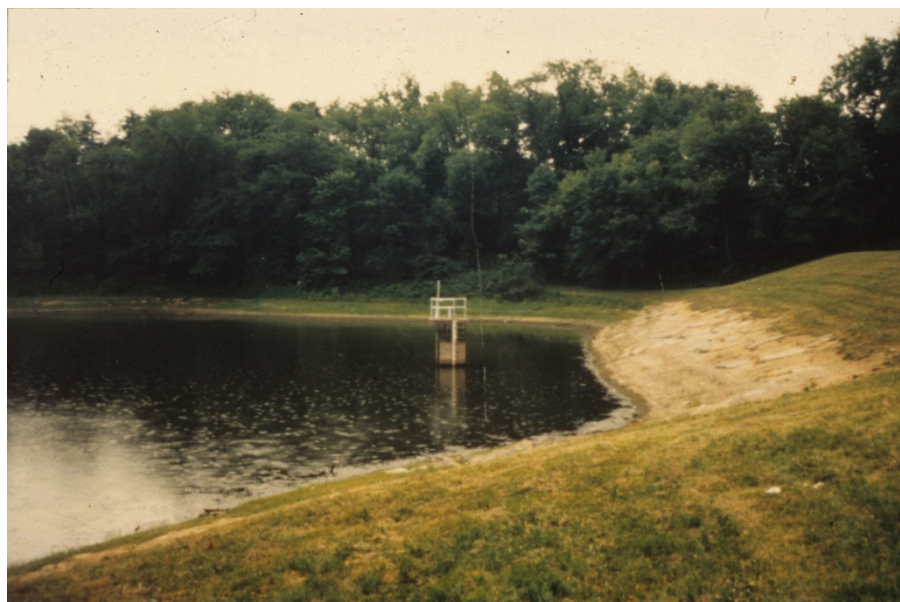
This is a photograph of Zoar Diversion Dam in 1991 when it still impounded a permanent lake.

This lake was commonly referred to as Lime Kiln or Goose Run Lake. The lake was permanently impounded to elevation 916'. The control tower can be seen in the middle ground.
